Risk Assessment of Earthquake on Historical Structures and Monuments

Abstract - This paper discusses the risk assessment of earthquake on historical structures and monuments as per their height and shape with reference to the earthquake that occurred on 25 April 2015 and on 12 May 2015. Heritage Site, Dharahara tower, which was very high-rise in height, totally collapsed. Owing to such height the upper portions of 9-storied Basantapur Durbar, the Dasa Avtar temple were demolished by the quake.

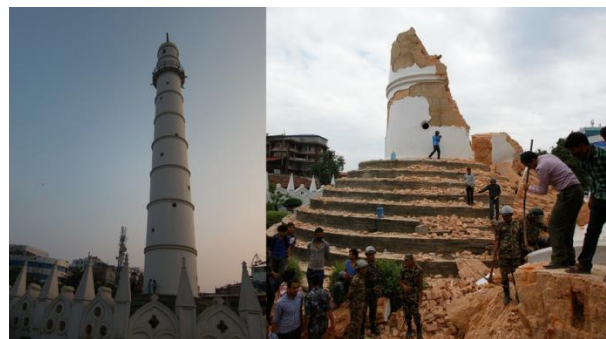
Fig. 7 a & b. Dharahara Tower before & after quake

- In Dharahara Tower, Kathamandu, situated in Zone V, the 8 mtr high stepped Foundation/Platform square in plan area 380 sqm, safe during & after earthquake, but 62 mtr high circular shaped in plan Super Structure tower, above plinth/platform collapsed 84 % in height, during & after earthquake.
